# Manhole Inspection Summary

Manhole # S31AA1009MH

**Location** Address: **SAN MARTIN DR**

Cross Street: **JOHNS HOPKINS UNIV**

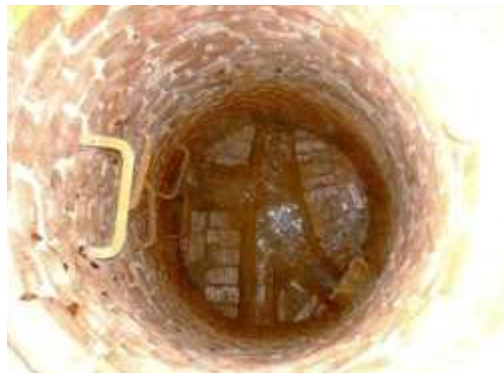
Corroded steps. Bench debris.

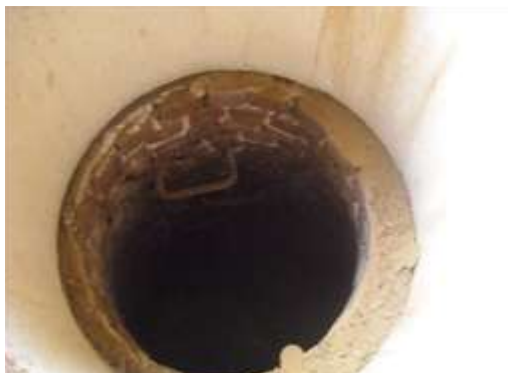
Defect

Corbel and Barrel infiltration.

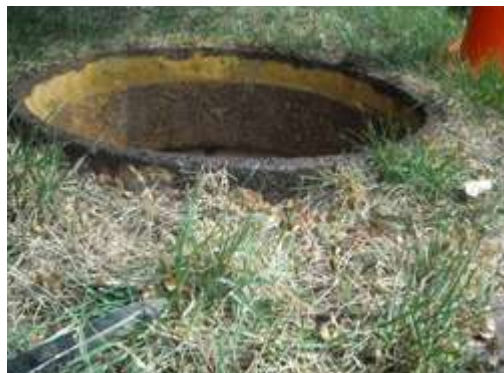
Defect

Above grade.

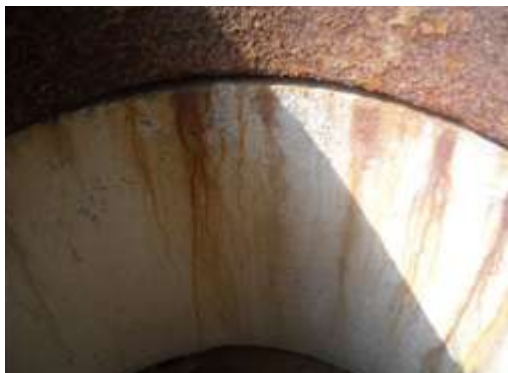
Defect

Corbel infiltration.

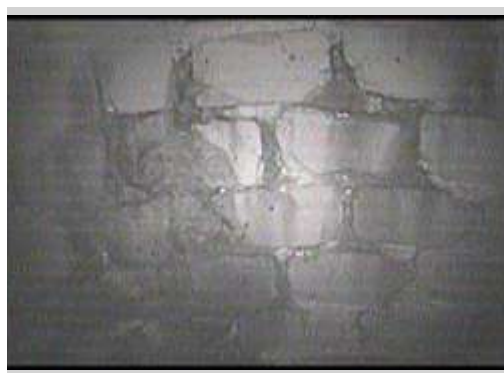
Defect

Comments **There appears to be active infiltration in the Barrel of this MH.**

Barrel infiltration (Active).

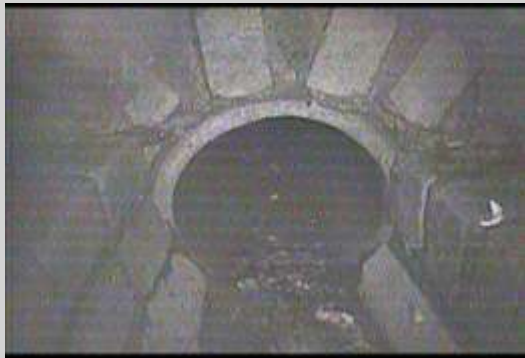
### 8 in. Circular Gravity Sewer Pipe Out @ 12 O'Clock

Deposits: ☐ None ☒ **Mud** ☒ **Sludge** ☐ Debris ☐ Grease

Silt Depth: **1** (in.) Deposits Extent: **Light**

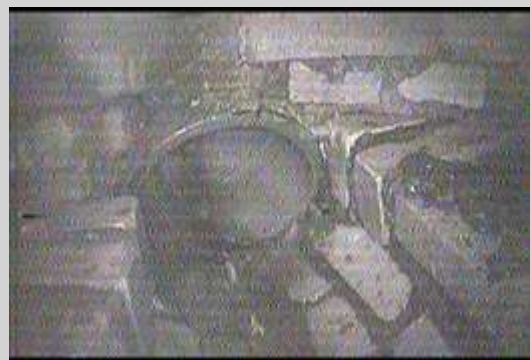
### Drop In @ 4 O'Clock

Drop Condition: **Partly Clogged**

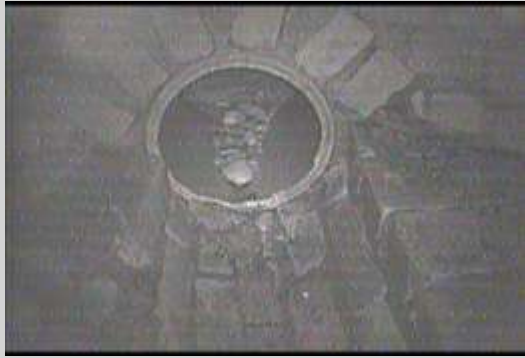
### Pipe In @ 6 O'Clock

Connects To: **Stub connection / abandoned**

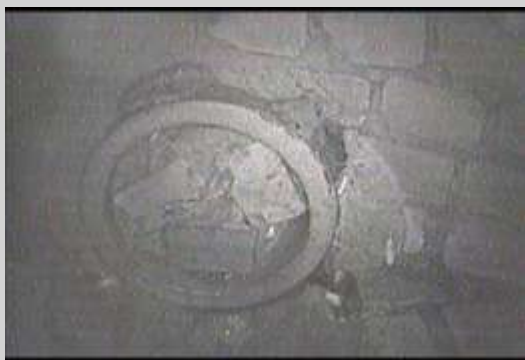
### Pipe In @ 10 O'Clock

Connects To: **Stub connection / abandoned**
